British Gliding Association
Aircraft Inspection

Mandatory

Number: 042/07/2004	Issue: 1
------------------------	-------------

- Subject:** Structural inspections
- Applicability:** Schleicher Ka 1, Ka 2, Ka 2B, Ka 3, Rhönlercher II (Ka 4), Ka 6 series, K7, K7 conversions, K8 series, K9, K10, ASK 13 series, ASK 14, ASK 16, ASK 18 series and all variants of each type.

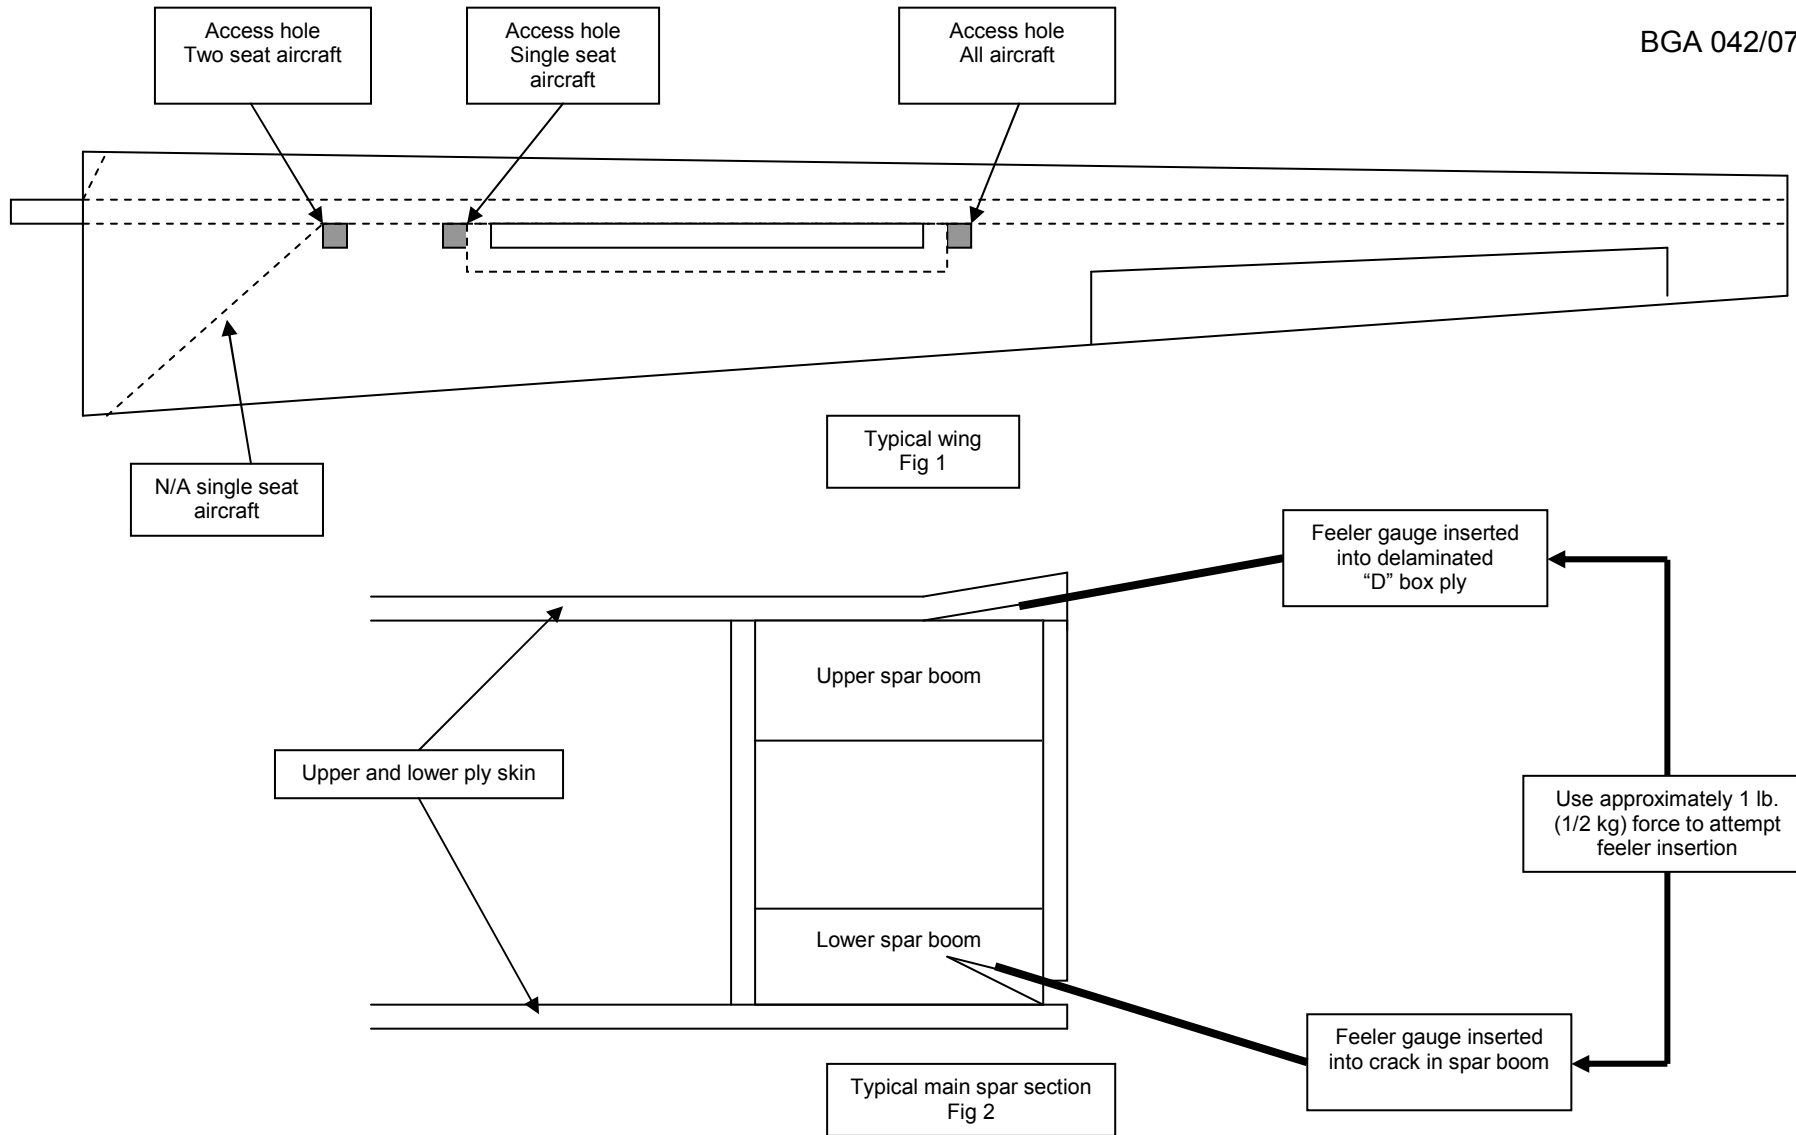
Make 4 access holes in the fabric approximately 2" (50mm) square (2 upper surface and 2 lower surface) at the following locations:

Single seat aircraft: Adjacent to the rear face of the main spar immediately inboard and outboard of the air brake box. See fig 1.

Two seat aircraft: Adjacent to the rear face of the main spar immediately outboard of the air brake box and at the drag spar intersection with the main spar. See fig 1.

Through the inspection holes, inspect the internal structure of the wing trailing edge using a torch and mirror or suitable inspection equipment. Pay particular attention to the air brake box and drag spar attachment to the main spar.

Using a 005/010" (0.12/0.25mm) feeler gauge, try to insert into the glue joint parallel to the wing top surface. See fig 2.

Check for cracks running into the spar booms by trying to insert the feeler at 45° to the spar. Apply a force of approximately 1 lb. (1/2 Kg) See fig 2.

If the feeler gauge can be entered more than 3/16" (4mm) or any evidence of glue failure is observed the aircraft must not be flown. All the fabric must be removed and a complete structural survey carried out. An inspection report must be submitted to the CTO for further instructions.
